## LABORATORY ANALYSIS REPORT

**Herguth Project Number: #717258A**

**Sample Description: Electrical Contact Resistance Analysis, Pin-On- Disk Method (ECR-POD) of Motor Silk CLS Bond**

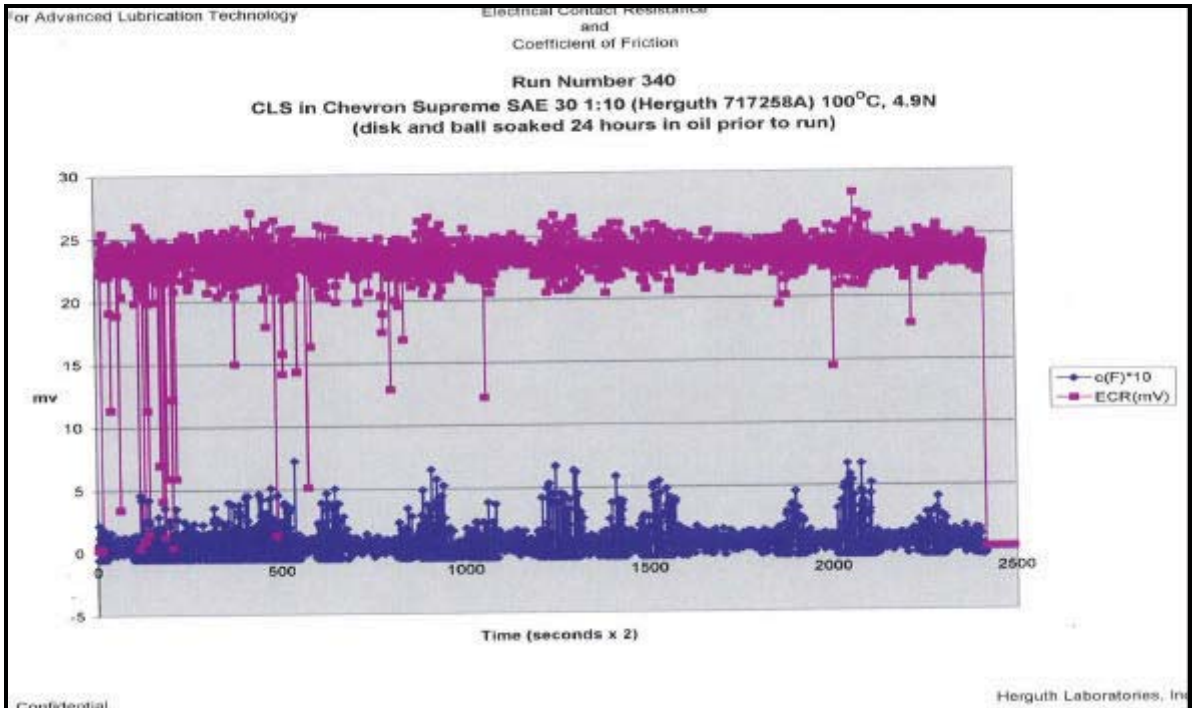
*24 Hours Soaking  
ECR-POD CHEVRON SAE 30 MOTOR OIL and MOTOR SILK*

The third and final test was performed on a pin and disk pair that had been soaked for 24 hours in a blend of Motor Silk and Chevron reference oil. As can be seen in Graph # 3 a film had formed simply by soaking the pin and disk.

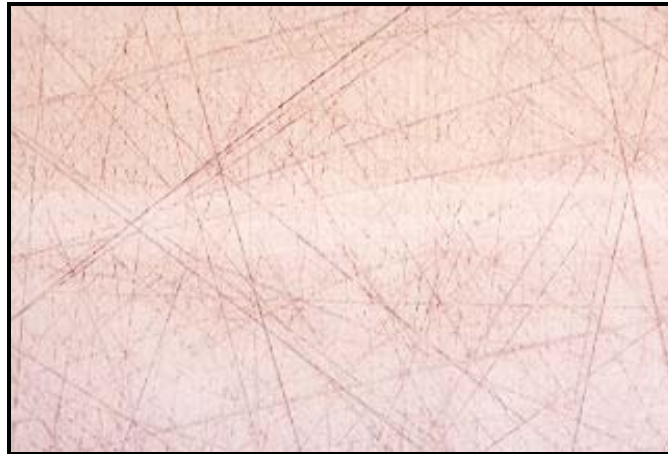
Description: CLS mixed with Chevron SAE 30 1:10  
Temperature of run 100 degrees C  
Load of 4.9N  
Time of 20 minutes

Photo of Disk 100X
